AAF Technical Report 5230

ATSC COLD WEATHER TESTS WINTER 1944–1945

Report No. 5230
Date: 31 May 1945

Climatic Requirements Office
Service Engineering Branch
Engineering Standards Section
Service Engineering Subdivision
Engineering Division

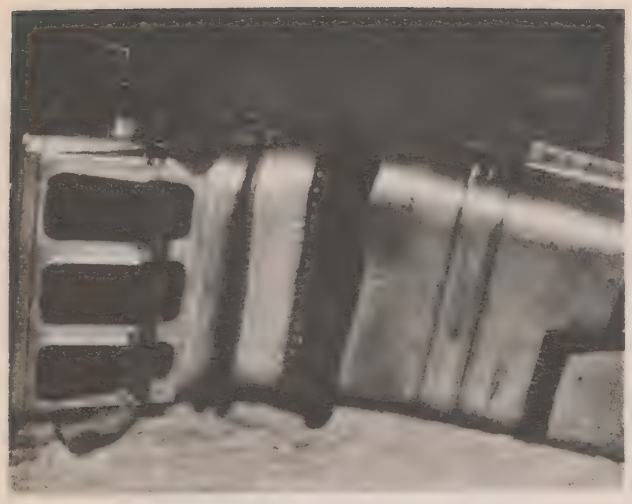
B-24 Intercooler Duct—Accessory Section Gate

1. This type carburetor heat system was installed on the No. 2 engine of Air Technical Service Command cold weather test airplane B-24J Serial No. 44-41378. The duct ahead of the intercooler on the No. 2 engine was reworked and was provided with two sets of gates one located at the front end of the duct, Figure 1, and the other on the accessory section side of the duct, Figure 2, so that with heat ON the intercooler intake air would be cut off ahead of the intercooler and warm air from the accessory section would be allowed to flow through the intercooler. The gates were operated by an electric motor through gear segments. The intercooler shutters on this engine were disconnected from the drive motor and safetied open, and the wiring was rerouted and connected to the motor which drove the carburetor heat gates. In order to allow control of the carburetor heat gates a momentary contact type switch was installed

2. This system was based on the theory that warm air from the accessory section would circulate through the accessory section gates and thence through the intercooler when carburetor heat was turned ON, thus utilizing the intercooler as an interwarmer without affecting carburetor air in any way except for heating. It was realized that the effectiveness of this system would depend on the temperature of the accessory section air which in turn varies directly with the outside air temperature. It was not known, however, just what heat rise could be obtained and just how critically it would be affected by low outside air temperatures. In an effort to control the flow of warm air through the intercooler, an adjustable scoop 5¼ inches long controllable in ⅛ increments from 0 to 1¾ inches, which could be actuated from the bomb bay, was installed in the inside wall of the carburetor air intake duct as shown in Figure 3. It was anticipated that the scoop opening at which the greatest heat rise could be obtained at any power setting and altitude could thus be determined since a compromise had to be made between the amount of pressurization of the accessory section and the quantity of cooling air which would enter the accessory section through the pressurizing scoop.

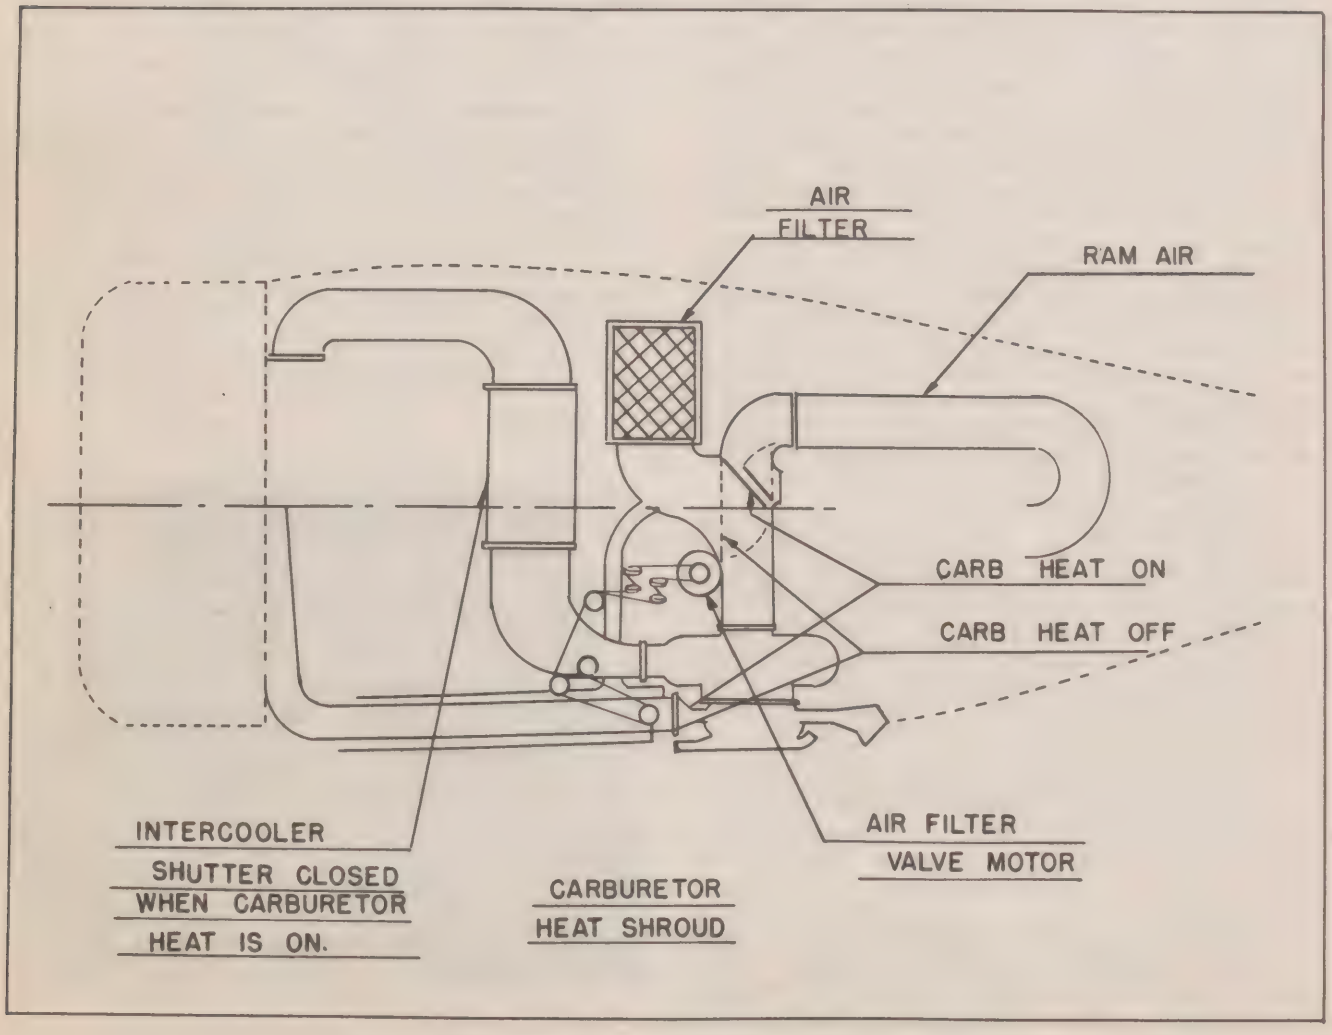
B-17 Carburetor Heat System Ducting

1. An exhaust manifold type carburetor heat system was installed on the No. 1 engine of Air Technical Service Command cold weather test airplane B-17G Serial No. 43-38221. It consisted of a stainless steel shroud around the exhaust manifold, Figure 4, from which hot air was ducted from the right rear side of the upper shroud to the induction system below the air filter by means of a 4¼ inch I.D. flexible aluminum tubing wrapped with strip asbestos as shown in Figure 5. Since the hot air duct was tapped into the induction system ahead of the air filter valve as shown in Figure 6, turning the air filter ON on this engine allowed flow of hot air instead of filtered air. A gate was provided at the rear of the shroud to minimize as much as possible the loss of heat and hot air from the carburetor heat shroud. This gate was actuated through a pulley system from the air filter valve motor, as shown schematically in Figure 7, in such manner that it closed when carburetor heat was

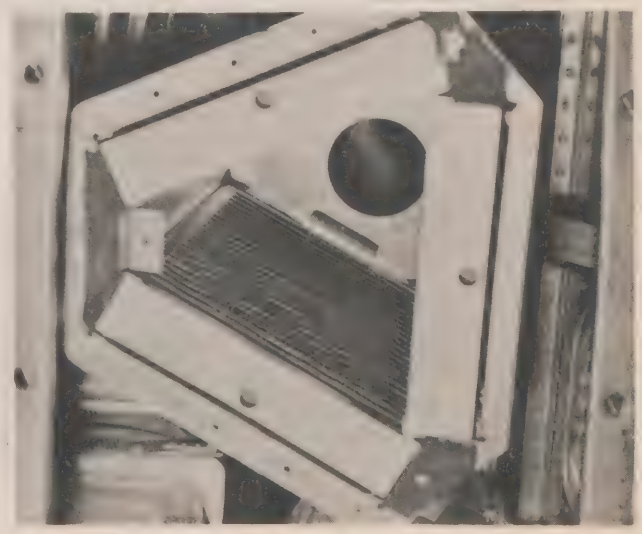
B-17 Air Filter Restrictor Plates

2. The next best arrangement of the exhaust manifold carburetor heat system on the B-17G which gave the maximum carburetor air temperature rise and at the same time allowed feeding of the engine with no greater pressure drop that that experienced by turning on the air filters on the production engine installation was that using the plain shroud and the No. 1 (4" diam. orifice) air filter restrictor plate. At 600 hp and 2000 ft. a carburetor air temperature rise of 22°C was available which is only about 44% of that required as compared to the 3°C average heat rise on the production engine which comes to only 6% of meeting requirements described before. As shown in Figure 6 the heat rise available decreased with decrease in power and increased with increase in altitude as might be expected, however, the results of tests No. 1 and 2 plotted in Figures 4 and 5 indicated that at powers less than 600 hp the carburetor air temperature rise tended to increase. Sufficient data to verify this tendency are not available. The carburetor air temperature rise available during the traffic pattern and final approach were each 24°C which were 6°C and 10°C less than the arrangement using the No. 2 (2¾" diam. orifice) air filter restrictor plate. These heat rises are not considered quite adequate for this condition of flight.

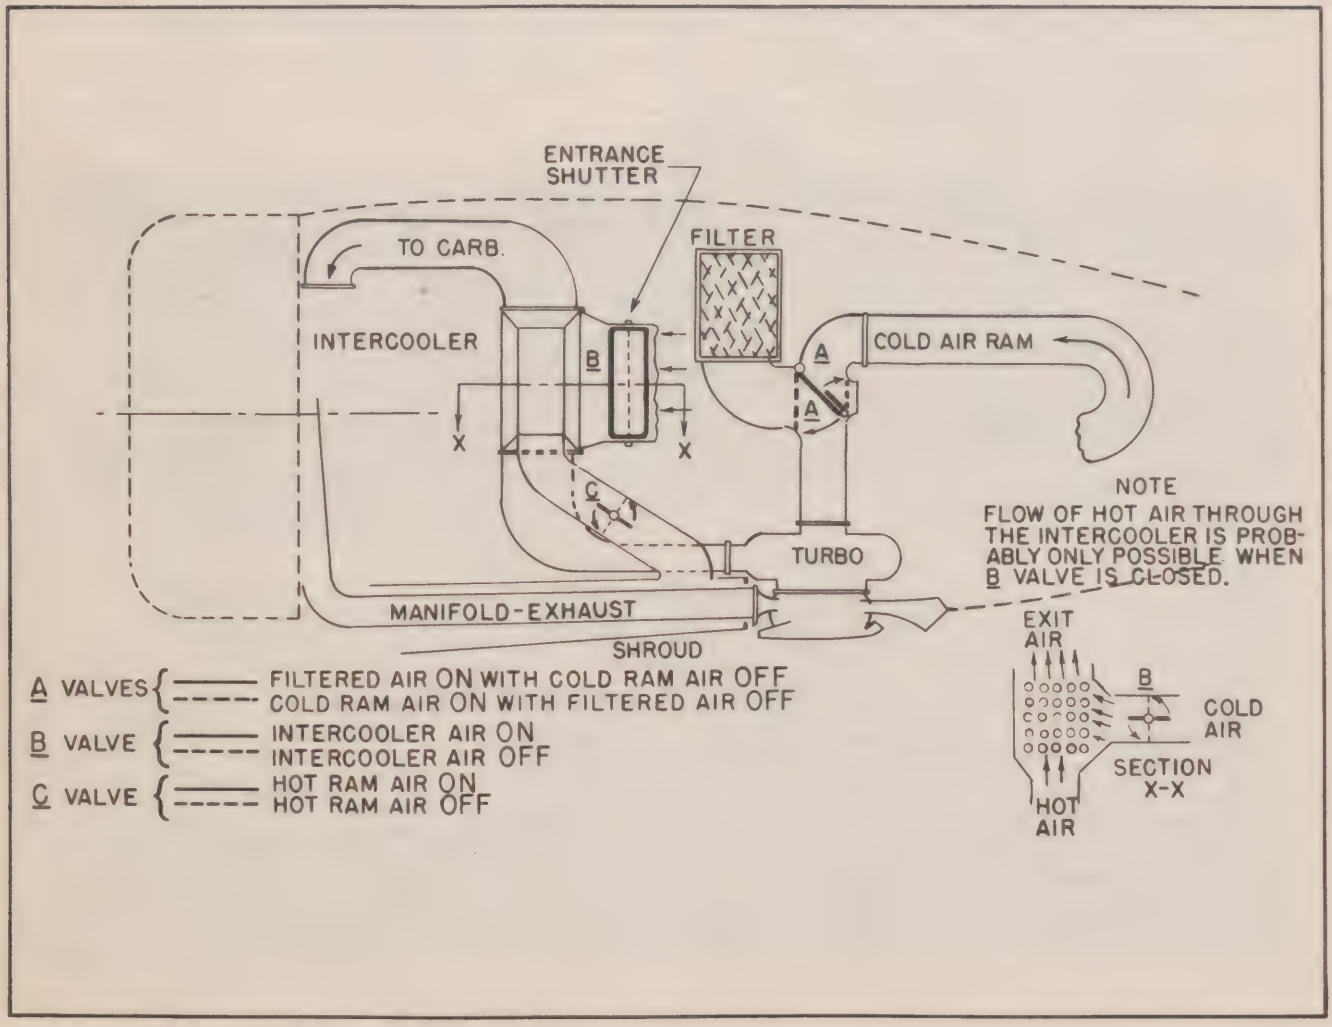
Schematic Diagram of Proposed Inter-Warmer Type Carburetor Heat System

2. Another carburetor heat system which is a development of the accessory section type carburetor heat system tested on a B-24 and discussed in this report is shown in Figure 2. This is merely a proposed system since no data is available on its performance. It consists essentially of ducting hot air from a shroud around the exhaust manifold into the intercooler. Such a system demands the use of entrance type intercooler shutters so that ram air can be closed off ahead of the intercooler and thus will not prevent flow of the hot air. It is believed that the ram effect at the hot air shroud will be sufficient to flow the hot air over the intercooler tubes. The amount of ram and area of ducting which will provide the greatest possible heat transfer to the carburetor air are all factors of design and test which must be determined. It is not known whether or not the rapidity of carburetor heat rise would be sufficient to allow use of this system as a means of combating carburetor ice. It is believed that this system would provide all the heat rise desired at

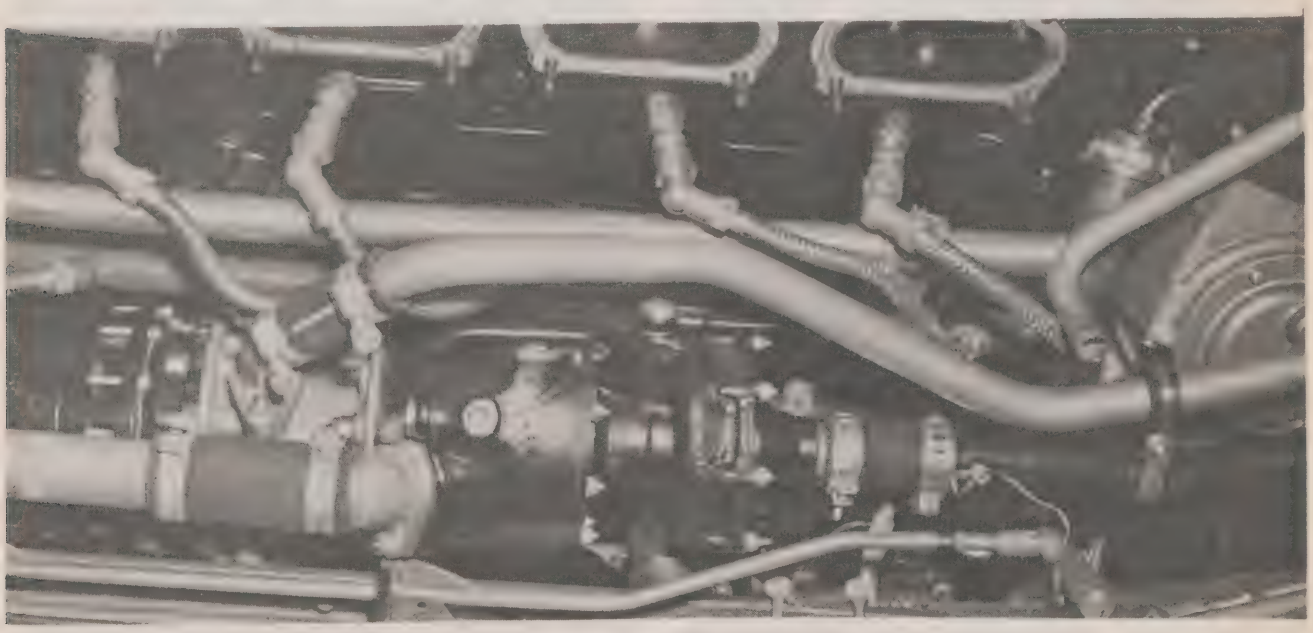
2. Three flight tests were made with 15, 20 and 30% dilution with the Thompson centrifuge. The results of all three tests were approximately the same. In each case, a small amount of oil could be seen on the fuselage after the flight, and in all cases this could be considered negligible.

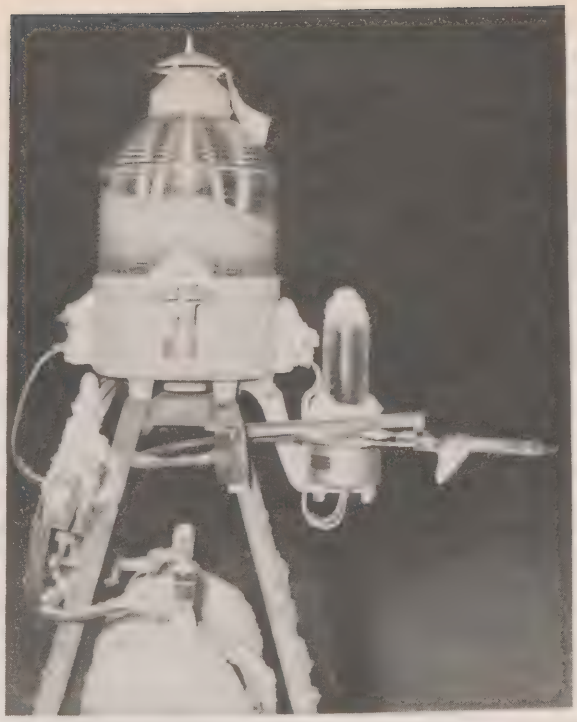
4. The alteration proved to be effective as there was no furthur accumulation of frost inside the lens.

5. Photographs Nos. 2 Appendix A, illustrate the extent of frost accumulation before the alteration was made, and Photograph No. 5 shows the baffle that was applied to correct the difficulty.
